# *Property Condition Report*

1234 School House Road  
Yourtown, US 12345

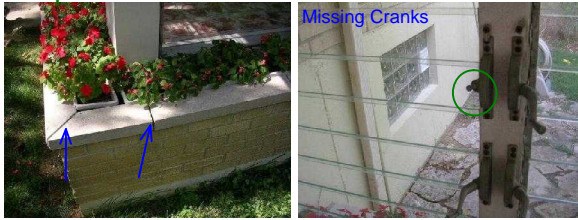
5. Marginal      Patio/Enclosure: Ceramic tile, Brick, Aluminum windows - **Loose limestone wall caps, Missing screens and some cranks, Lubricate as required**

3. Patio/Enclosure: Ceramic tile, Brick, Aluminum windows - Loose limestone wall caps, Missing screens and some cranks, Lubricate as required

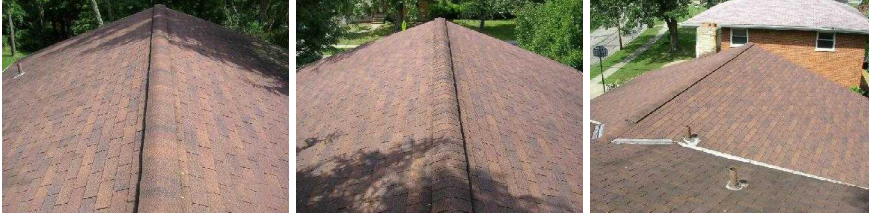
Material: Fiberglass shingle - Moss growth noted

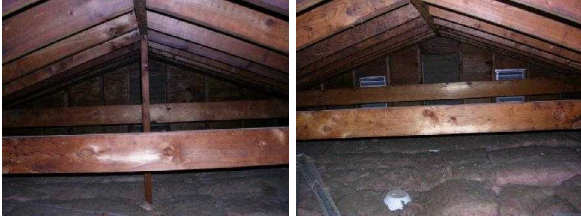
- 2. Acceptable      Unable to Inspect: 20%
- 3. Acceptable      Roof Framing: 2x6 Rafter
- 4. Acceptable      Sheathing: Plywood
- 5. Acceptable      Ventilation: Roof and soffit vents
- 6. Acceptable      Insulation: Fiberglass
- 7. Acceptable      Insulation Depth: 10"
- 8. Marginal        Attic Fan: Direct drive - **Install junction box with coverplate at open splice to attic fan**

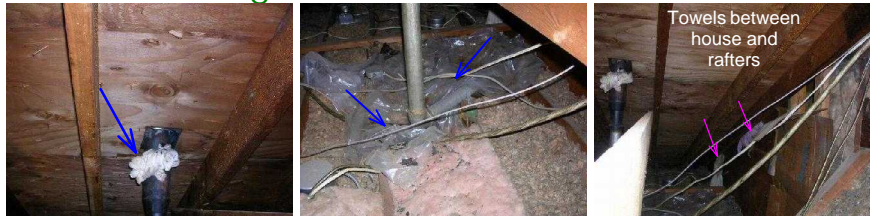
- 17. Acceptable Insulation: Fiberglass
- 18. Marginal Insulation Depth: 3" - 10" - **Recommend additional insulation be installed**
- 19. Acceptable Wiring/Lighting: 110 VAC lighting circuit
- 20. Marginal Moisture Penetration: Previous water penetration noted - **Previous water penetration noted at plumbing stack penetration with plastic in attic to catch water and towels wedged between house and rafter- no current leaking detected - Monitor**

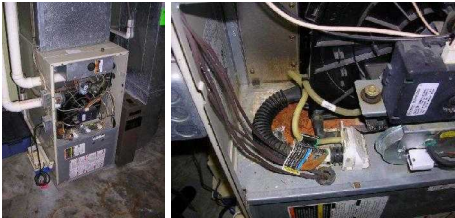
- Defective Heating System Operation: Note: - **Non-functional at time of inspection, A qualified HVAC technician is recommended to review and correct as required, Condensation leaking stains noted in cabinet**

8. Basement Heating System Heating System Operation: Note: - **Non-functional at time of inspection, A qualified HVAC technician is recommended to review and correct as required, Condensation leaking stains noted in cabinet**  
**Bathroom**

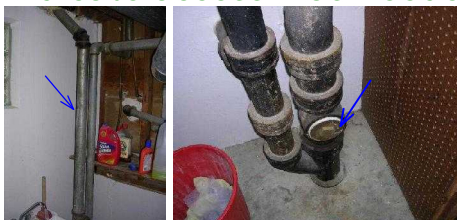
4. Marginal      Drain Pipes: Cast iron, Galvanized - **Slow draining noted at Tub. A licensed plumber is recommended to evaluate and estimate corrections, Galvanized drainpipe present- Galvanized piping corrodes from inside causing decreased flow rates and will eventually require updating. Noted new clean out cap which may indicate access was needed to clear drain clog**

<u>Plumbing</u>		
Drain Pipes: Slow draining noted at Tub. A licensed plumber is recommended to evaluate and estimate corrections.	\$ 10	\$ 80
Basement Water Heater Flue Pipe: Install screws at exhaust vent piping fittings	\$ 5	\$ 25

17. Drain Pipes: Cast iron, Galvanized - Slow draining noted at Tub. A licensed plumber is recommended to evaluate and estimate corrections, Galvanized drainpipe present- Galvanized piping corrodes from inside causing decreased flow rates and will eventually require updating. Noted new clean out cap which may indicate access was needed to clear drain clog

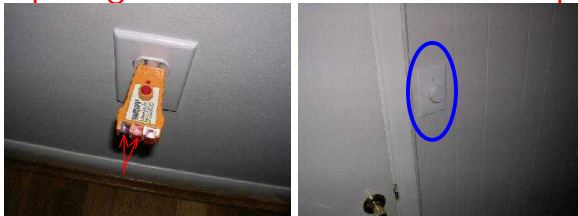
16. Defective      Electrical: 110 VAC - **Faulty operation at light dimmer switch-repair, Open ground exists at several 3prong outlet receptacles**

Lower Level Living Space Electrical: Faulty operation at light dimmer switch-repair	\$ 15	\$ 75
-------------------------------------------------------------------------------------	-------	-------

14. Lower Level Living Space Electrical: 110 VAC - **Faulty operation at light dimmer switch-repair, Open ground exists at several 3prong outlet receptacles**

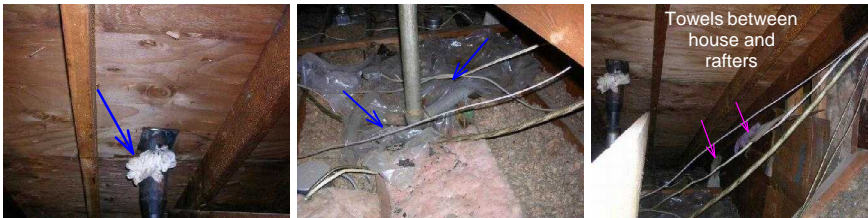
11. Partial house-Lower Attic Insulation Depth: 3" - 10" - Recommend additional insulation be installed
12. Partial house-Lower Attic Moisture Penetration: Previous water penetration noted - Previous water penetration noted at plumbing stack penetration with plastic in attic to catch water and towels wedged between house and rafter- no current leaking detected - Monitor
